**DEBRIS/ICE/TPS ASSESSMENT and
INTEGRATED PHOTOGRAPHIC ANALYSIS
OF SHUTTLE MISSION STS-110**

Armando Oliu
Process Engineering/Mechanical System Division/ET-SRB Branch,
Kennedy Space Center, Florida

April 8, 2002

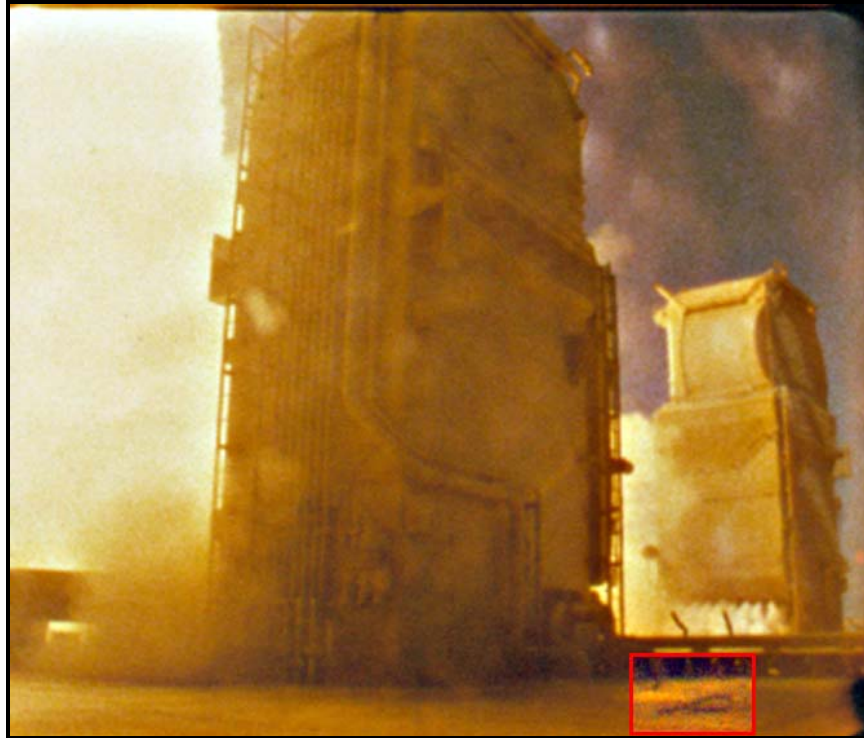
Figure 2.3.1 Debris Seen on MLP Deck During Liftoff (Camera E3)

Several pieces of facility debris were seen on the MLP deck near the LH2 TSM and the SSME exhaust hole during SSME ignition. During liftoff, the debris were blown in a westerly direction across the MLP deck. The debris were long and linear-shaped and appeared to be pieces of either cable or tubing. The debris moved away from the launch vehicle and were not seen to contact the vehicle. See Figure 2.3.1. (Camera E3)

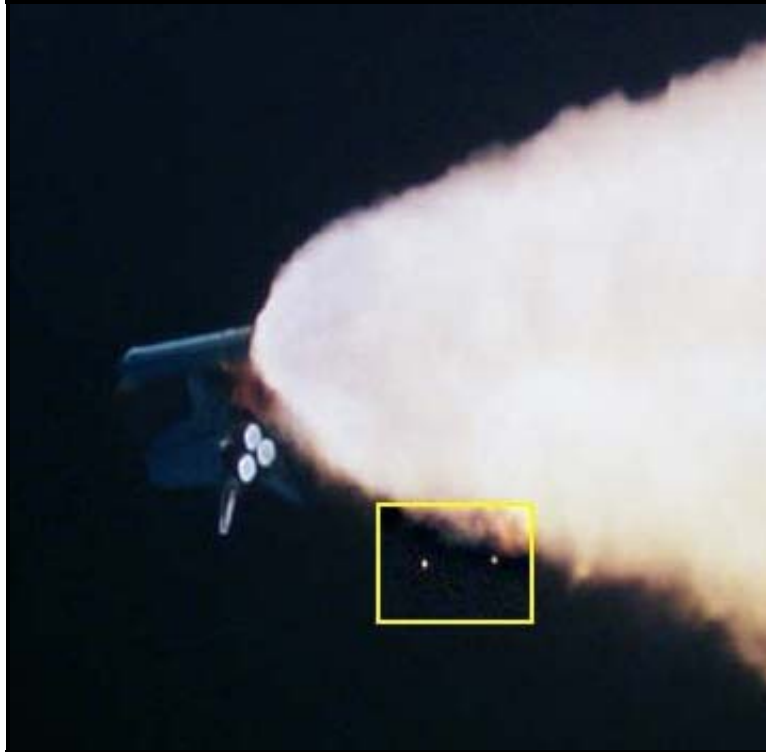
**Figure 2.3.2 (B) Debris Seen Exiting the SRB Exhaust Plume During Ascent
(Camera E222)**

As on previous missions, debris was seen exiting the SRB exhaust plumes during ascent. The debris exiting the SRB exhaust plumes during the majority of ascent was probably instafoam from the aft end of the SRB's. The more dense appearing debris near the time of tail-off, just prior to SRB separation, was probably SRB slag debris. Examples of this debris are provided in Table 2.3.2 (B). (Cameras KTV4B, ET207, ET208)

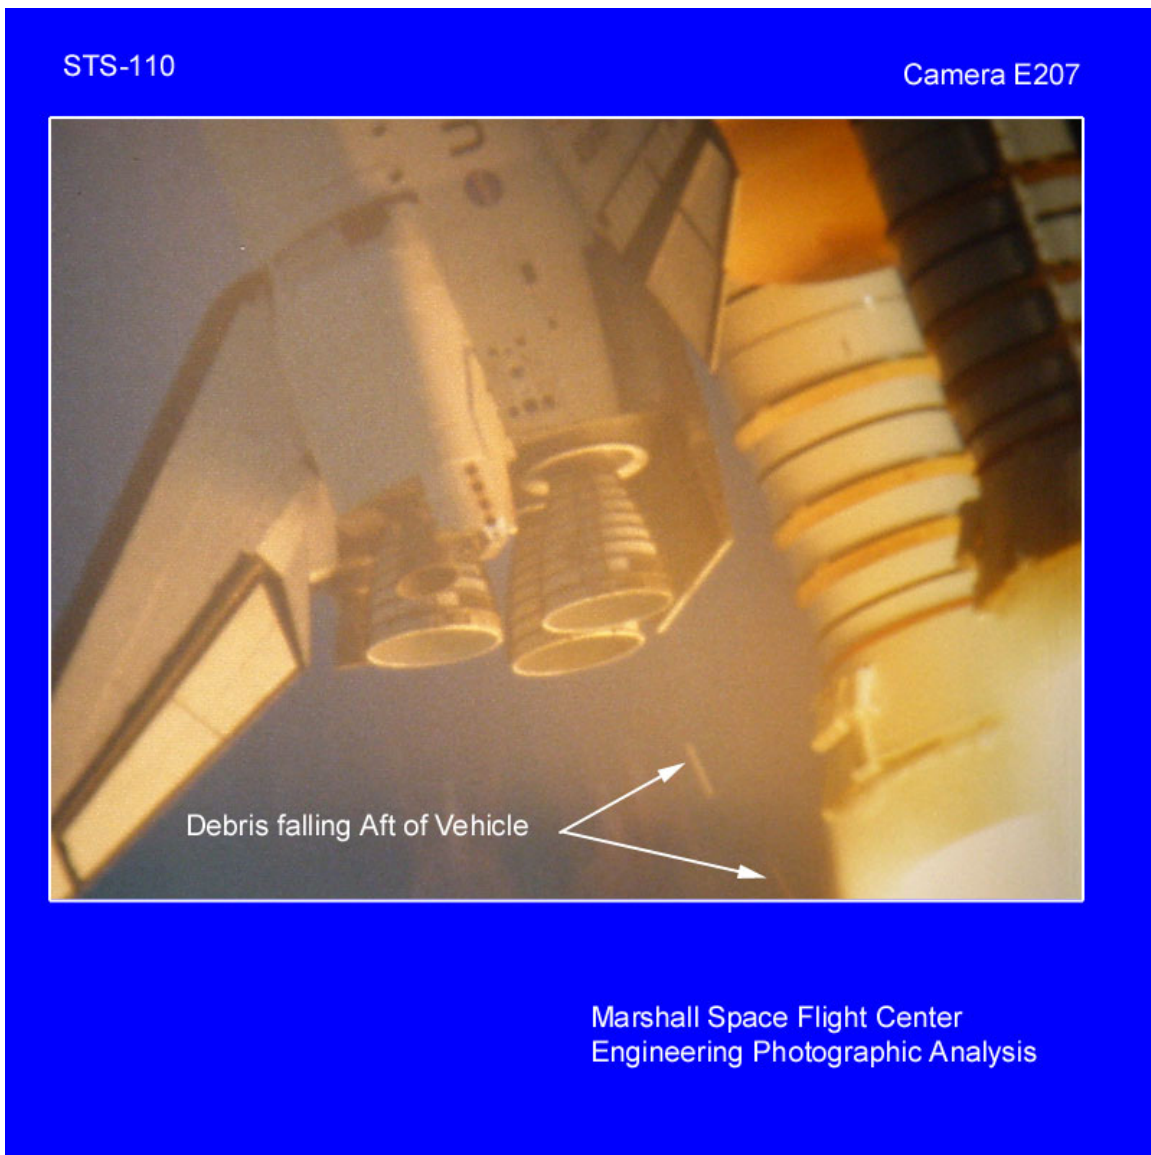
Figure 22. E207: Debris Falling Aft

Debris was observed falling aft of the vehicle during ascent.

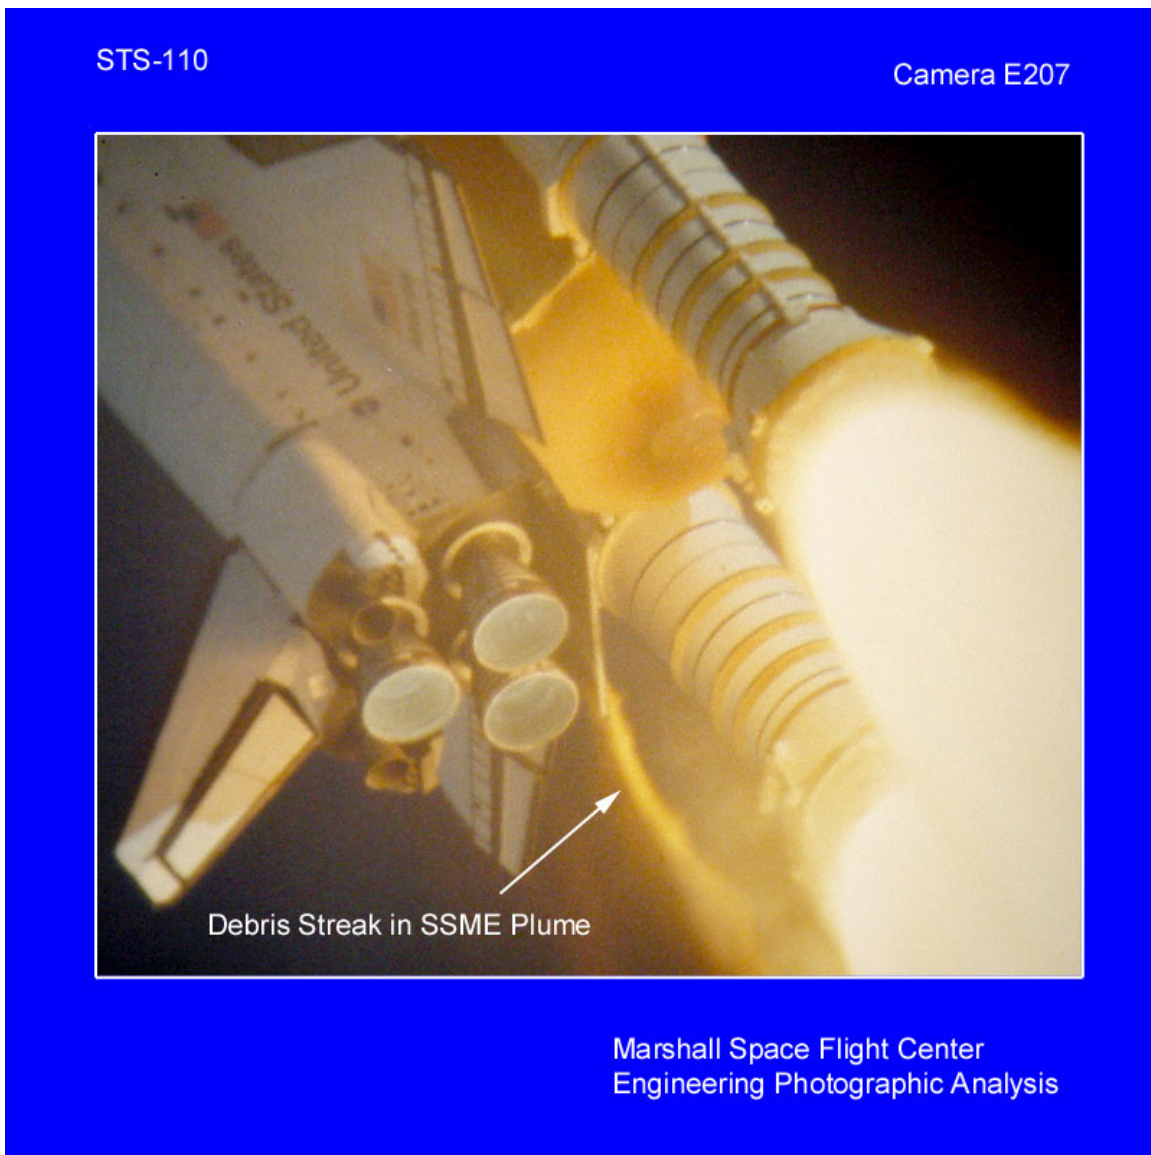
Figure 23. E207: Debris Induced Streak in SSME Plumes

A debris-induced streak was noted in the SSME plumes.

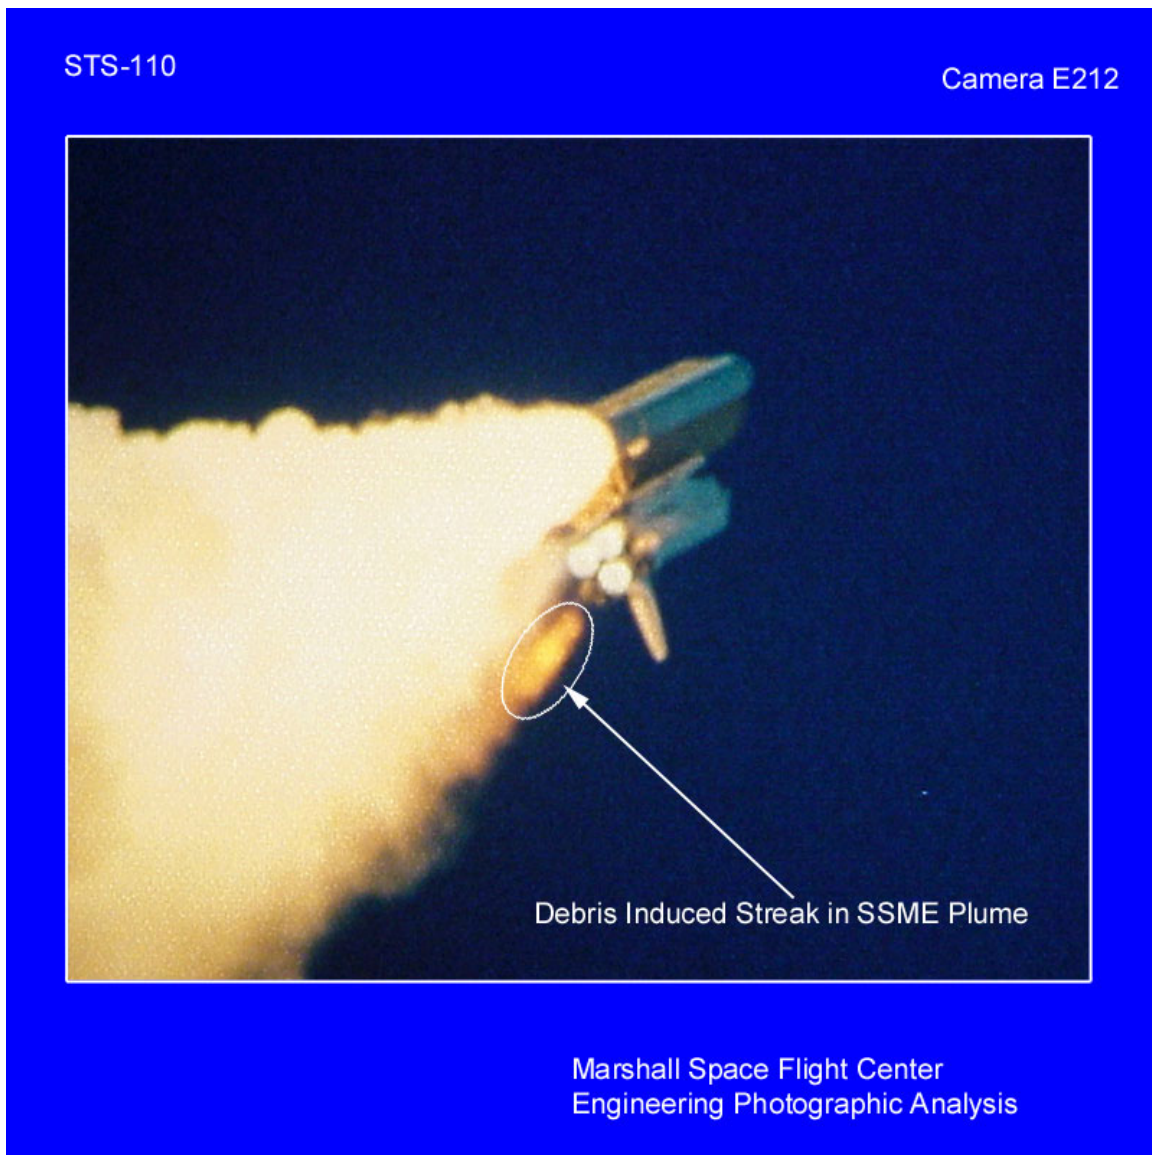
Figure 24. E212: Debris Induced Streak in SSME Plumes

A large debris-induced streak was noted in the SSME plumes.
